Comanche Landing Gear Maintenance session at Ellenville NY

Dwight Coombe, host for the May 16, 2015 NE fly-in at Resnick Airport, lead an in-depth discussion on issues related to the Comanche landing gear system. The topics ranged from possible causes for circuit breaker overloading, improper installation of bolts resulting in interference with gear movement, improper installation of wishbone linkages, and the emergency gear release spring missing or disconnected. Those in attendance provided accounts of problems with these items and the resulting actions taken.

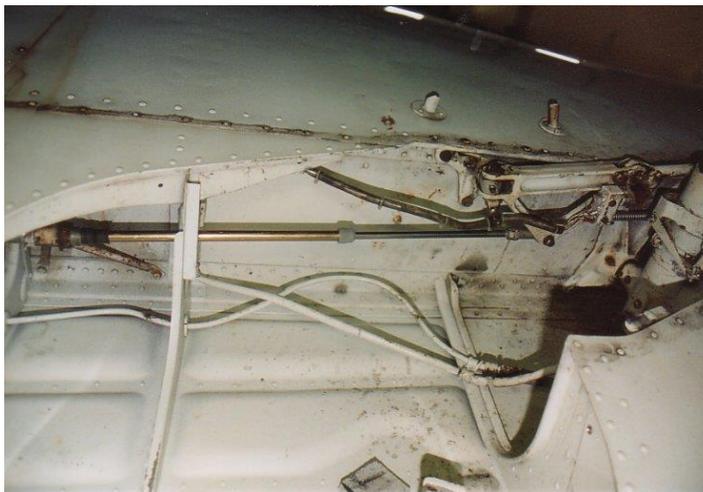
gear conduit in wheel well

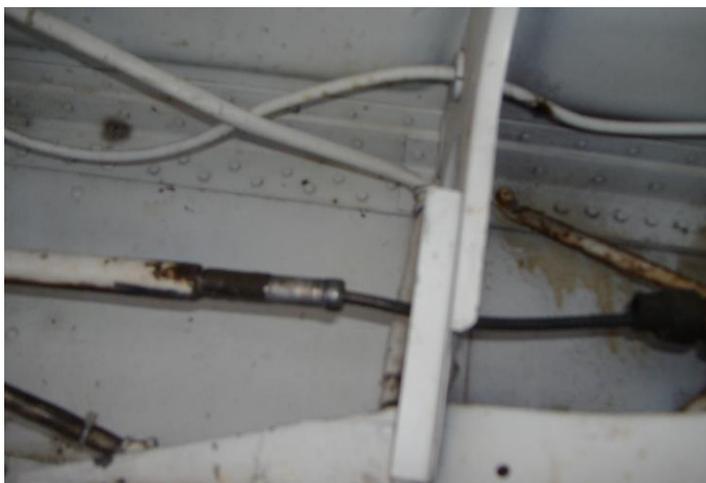
Most overloads occur when raising the gear, particularly in the last few inches of travel when the loads are higher. One cause could be excessive crud accumulated on the gear conduit telescoping tubes. Peter Morse had a gear collapse on landing due to this problem. Another could be failure or more likely miss adjustment of the up-limit switch, located in the floor just aft the nose wheel well. Discussion resulted in a few pilots sharing that their gear breaker has opened when raising gear on very cold days but that helping the gear up with the lever prevented the problem. Otherwise they found from ground testing that everything was normal

conduit jammed by crud

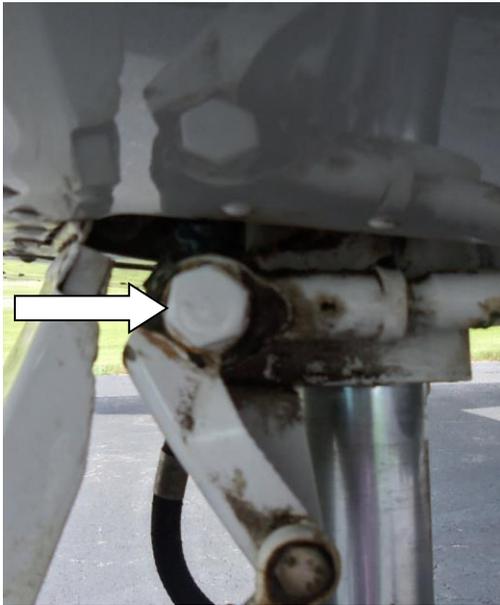
There are a couple of bolt fasteners that, if installed improperly, can result in contact with the wing underside and/or wheel well. This can result in damage to the sheet metal structure and prevent further movement of the gear (see arrows). Refer to the Piper Service Manual for proper assembly. Gear actuation while on jacks should reveal any problems.

flat head bolt

Threads and nuts should be aft in these installations.

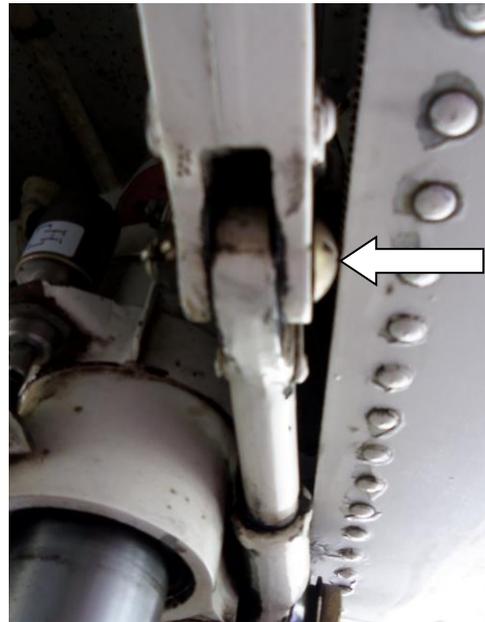
round head bolt clearance

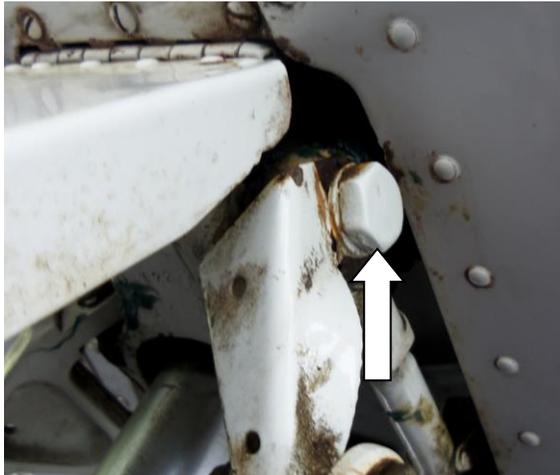
flat head bolt clearance

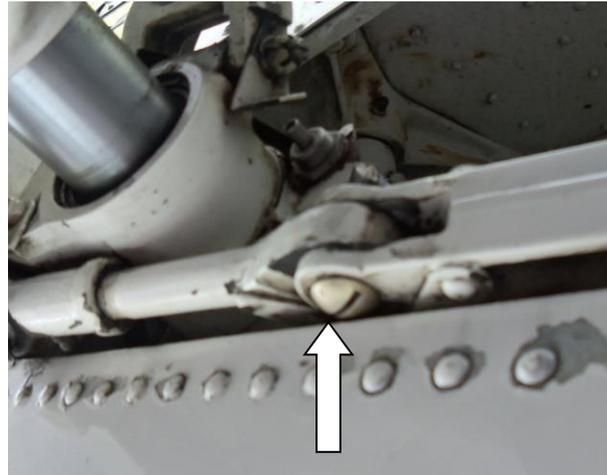
round head bolt

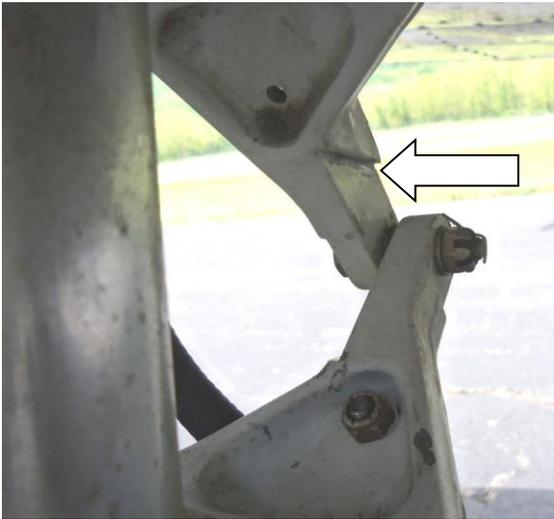
good main link

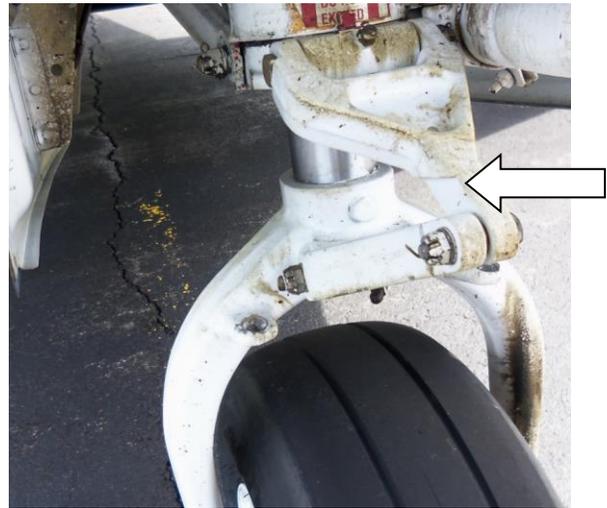
good nose link

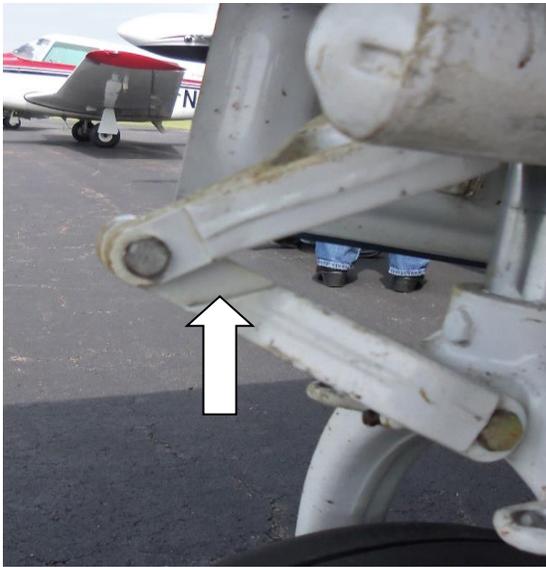
good nose assembly

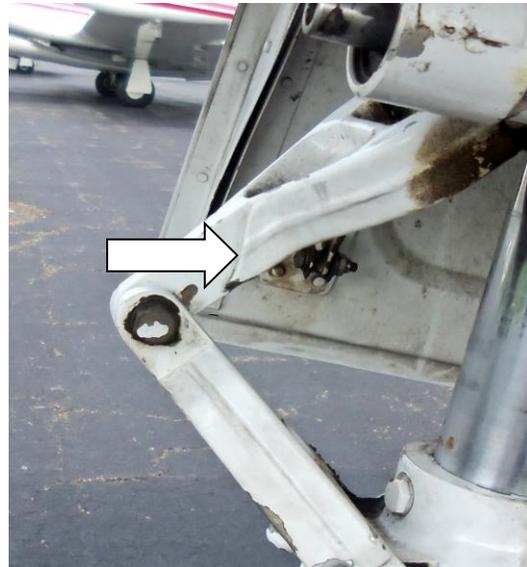
The wishbone linkages on each gear leg provide directional control while allowing the gear to flex up or down. Each wishbone arm has an area milled in the side (see arrows) which, when properly lined up, allow the assembly to compress further without binding. This allows full deflection to the gear oleo struts. Should the assembly bind up the resulting stress can shear the bolt positioned at the knee joint. Without this linkage the oleo strut is free to rotate. If broken, the nose gear will shimmy without connection, but should tend to track in the direction of aircraft motion. If this link bolt breaks at the main gear it will likely rotate 90 deg to the direction of travel with the tire dragging sideways on the surface. Bernie Stumpf had this occur when landing at Westerly RI, closing down the runway for nearly an hour. Without care, each wishbone arm, as well as the entire assembly, can be installed backwards. When properly installed the milled areas should face each other and the flat notch surface should be relatively horizontal to the ground. Zach Grant commented that, at one time nearly 18% of the Comanche fleet had improperly installed wishbones, many as factory original.

reversed nose assembly, binding spot

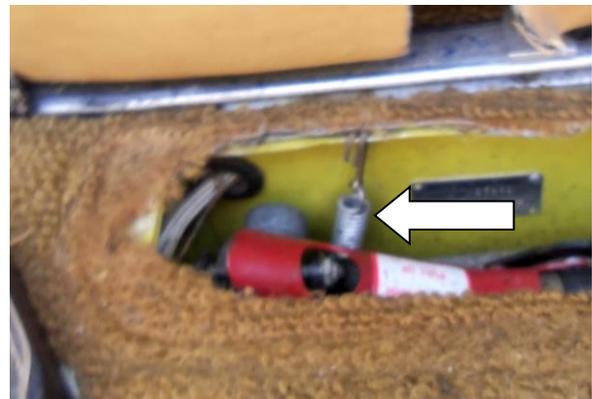
A spring under the floorboard (arrow) supports the gear motor assembly when the red handle is pulled to activate the emergency gear release. If the spring is not in place the assembly will drop and possibly jam, preventing further movement of the gear conduits. To continue to lower the gear someone will have to manually support the assembly, which could result in pinched fingers. When swinging the gear at each annual inspection, pay attention to the role of the spring in maintaining proper alignment of the worm gear assembly.

gear release support spring
