-Morse's long skid Home! -

Article #4: Faulty landing gear, and false indicator

by Pete Morse, Northeast Comanche tribe member since 2002

Pilot/owner N6632P

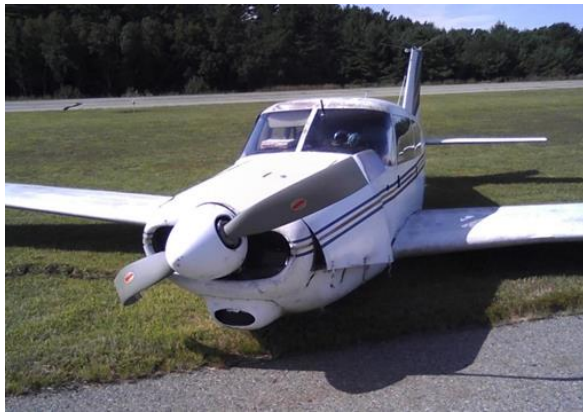
Shortly after touchdown the plane settled on its belly and slid toward the right, exiting the runway, eventually coming to rest across the grass at the Alpha taxiway and rotated 90 degrees to the direction of the slide. The engine stopped part way across the grass with signs of an obvious prop strike.

N6632P Final resting place

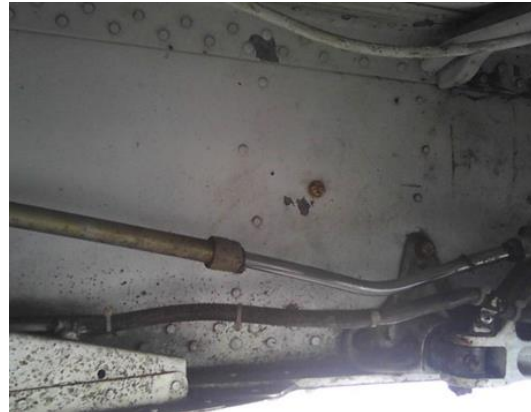
After getting permission to raise and move the aircraft, further inspection revealed that the gear motor circuit breaker was popped and the gear extension cables were bent. The gear was swung down (emergency release) and forced into position for towing. While the over-center gear locking arms were visibly not secure the "gear down" green light was on when tested.

It is my opinion that the **gear failed to extend fully** on downwind, possible as a result of the popped circuit breaker, and then gave a **false "gear down" green light indication**. On landing the unlocked gear slowly collapsed resulting in the belly skid, loss of control and prop strike.

extended/bent gear conduits
